**BAYTRONICS
CORPORATION**

TO: All Service Departments
FROM: Walter E. Kaelin, V.P. Engineering
DATE: March 20, 1980
SUBJECT: Mariner 80, Involuntary reverting to channel 16.

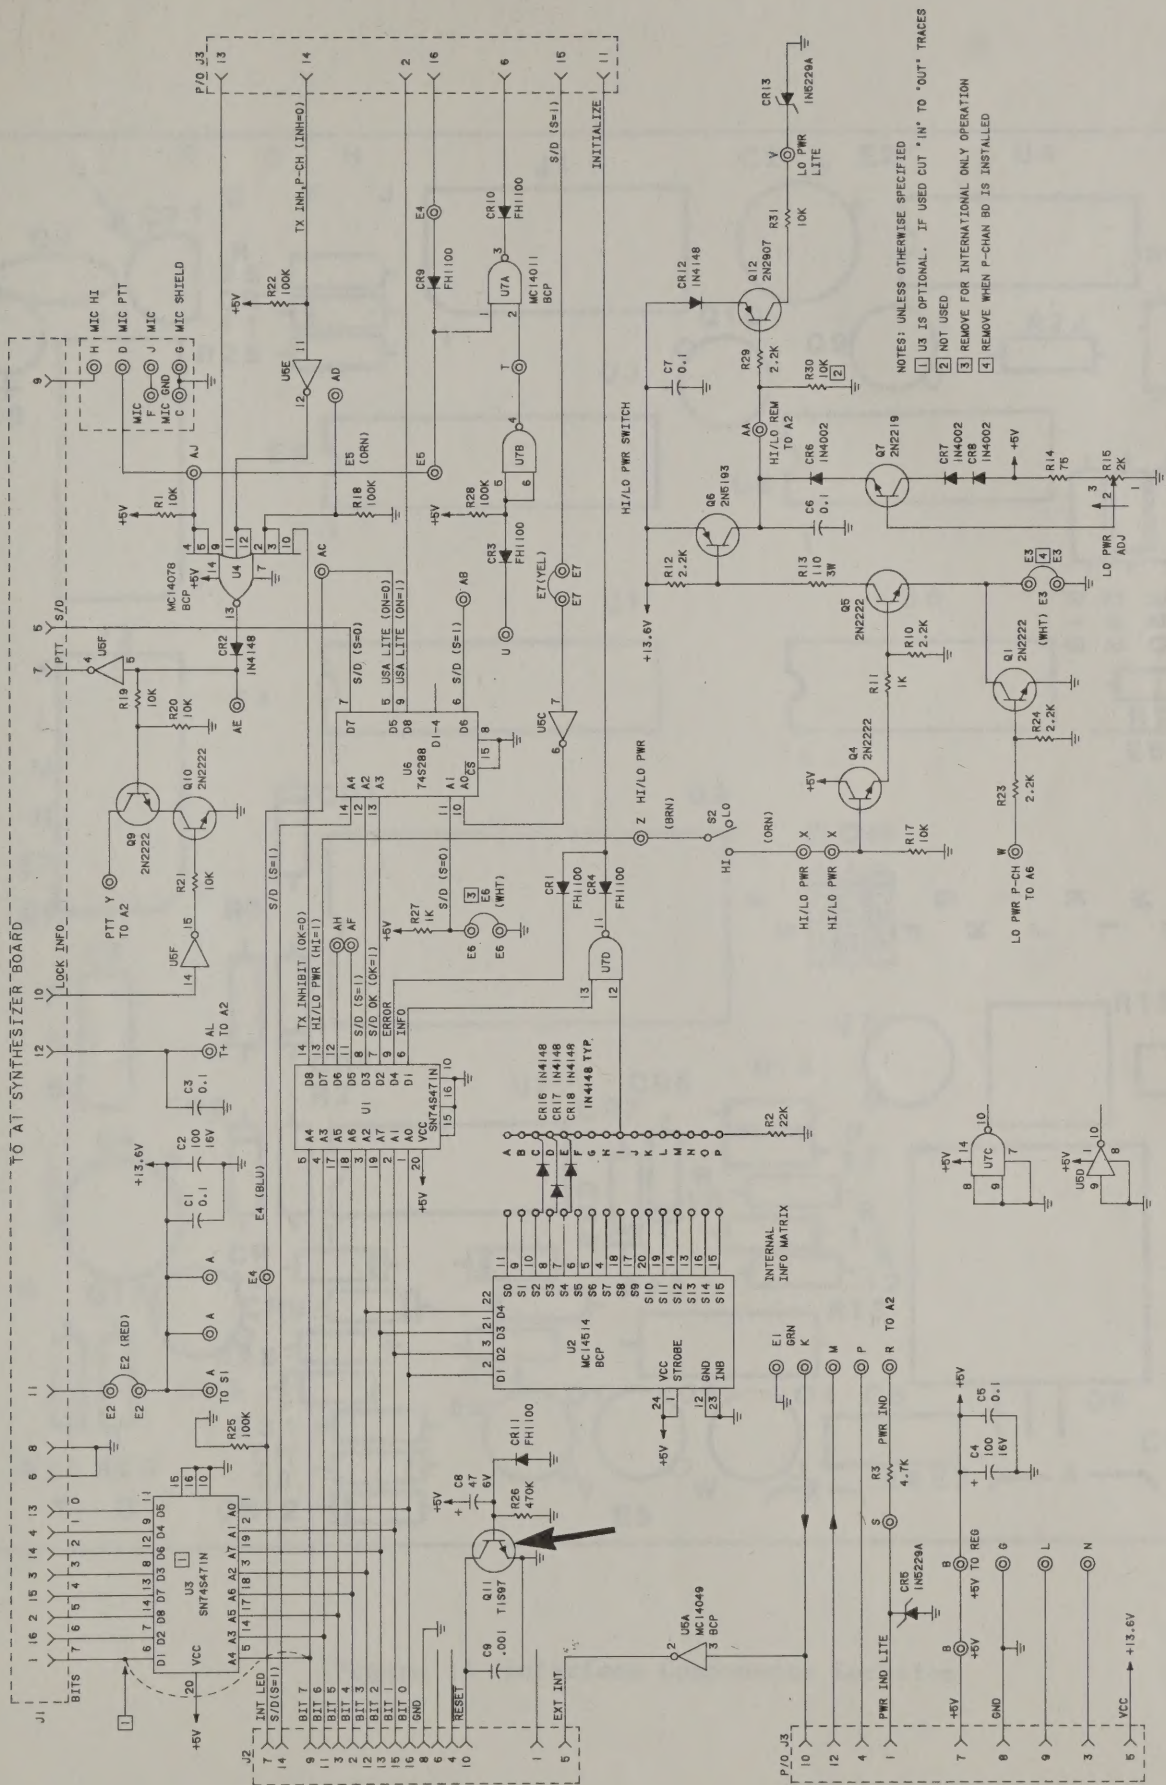
Figure 13 Interface Schematic

When installed in proximity of a strong R.F. field, it has been noted that certain Mariner 80 VHF radiotelephones, Serial Numbers 2000 and above, can involuntarily revert back to channel 16 from the operating channel. The R.F. field is usually from a 1 KW HF transmitter, but can sometimes be from a transmitting VHF antenna that is close to the Mariner 80.

The fix is simple: merely remove by clipping out Transistor Q11 (Type TIS97) on the A4 Interface printed circuit board. All Mariner 80's shipped since January 15, 1980 have already been modified at the factory.
